TEST REPORT

Report No. : HL30286/2026

Product Description: FurSeroll Series

Test Requested: Tensile Strength Test

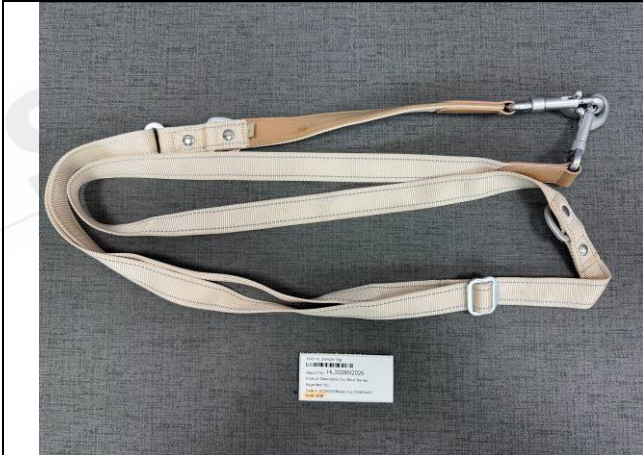
Photo A: Appearance of the sample(s)

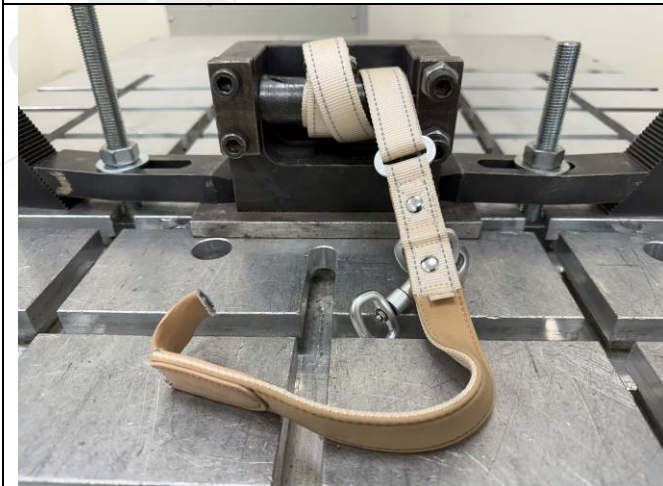
Photo C: After testing

Item	Position	Max. force (kgf)	Remark
FurSeroll Series	Handle part	131.9	The belt was damaged after testing. (As shown in Photo C)
